# Manhole Inspection Summary

Manhole # S17WW1004MH

**Location** Address: **NORTHERN PKWY**

Cross Street: **CLYBURN AVE**

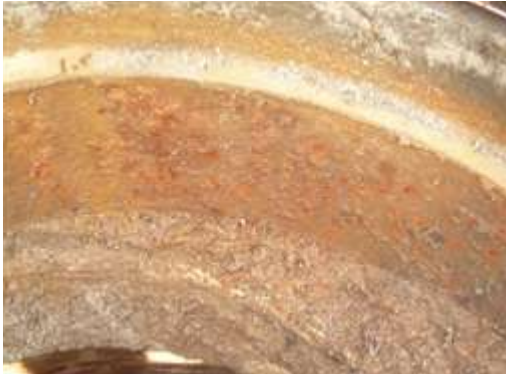
Defect

Frame leaks. Frame offset. Adjustment deterioration and infiltration.

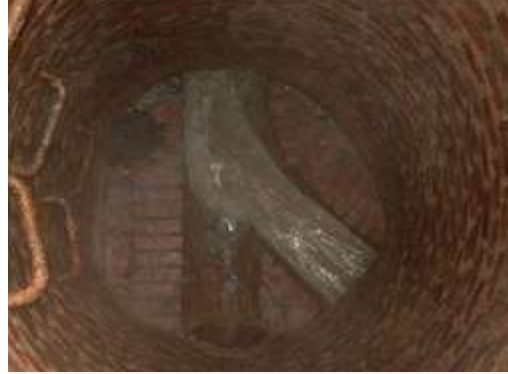
Top View

Barrel root intrusion and infiltration. Corroded steps. Evidence of surcharge - Bench debris. Channel debris.

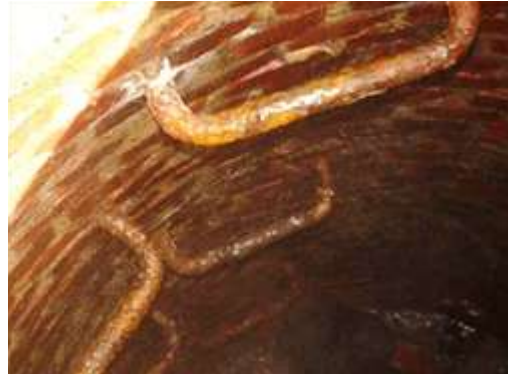
Defect

Corbel infiltration. Barrel root intrusion and infiltration.

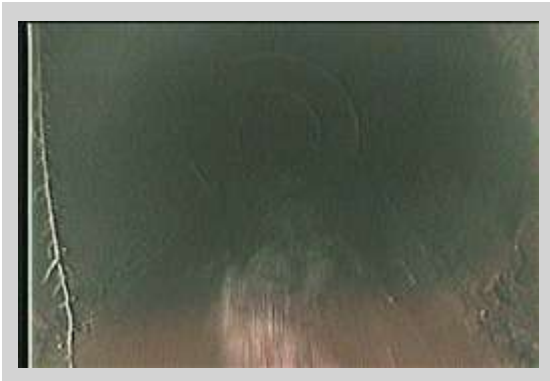
### 15 in. Circular Gravity Sewer Pipe In @ 4 O'Clock

Channel deterioration.

Infiltration: **None** Pipe Seal Cond: **Roots**
